Following the big-C_rework_SOP_rc2, this is how I applied the fix.

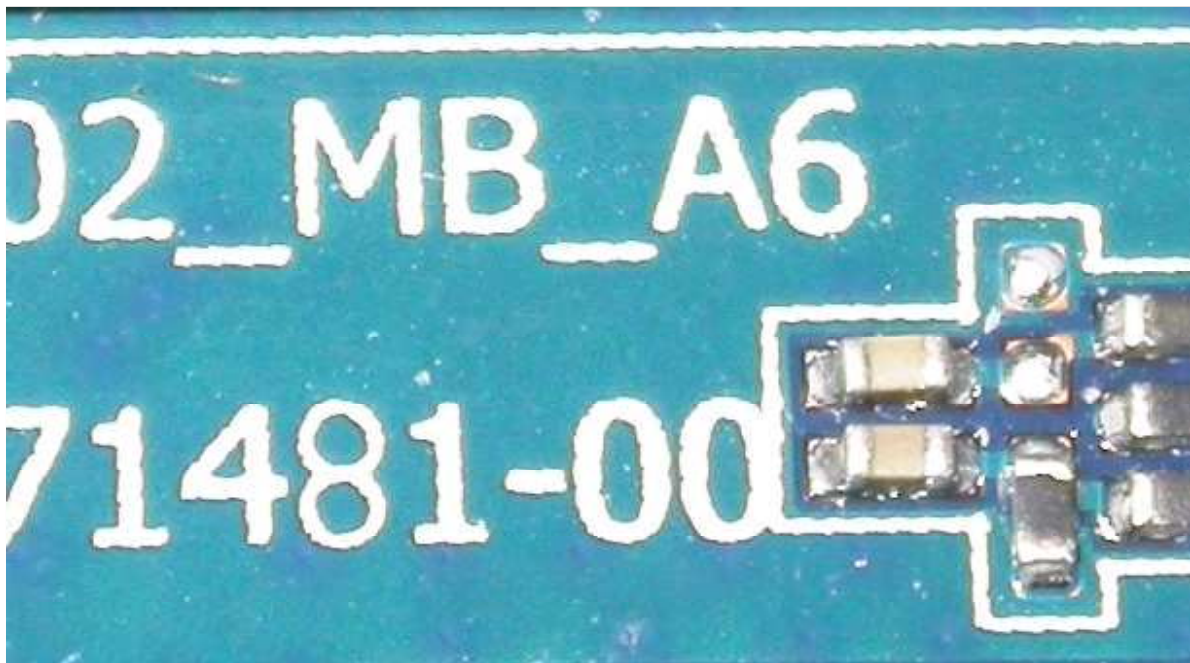
I probed R4303 and found it was 2k2 Ω

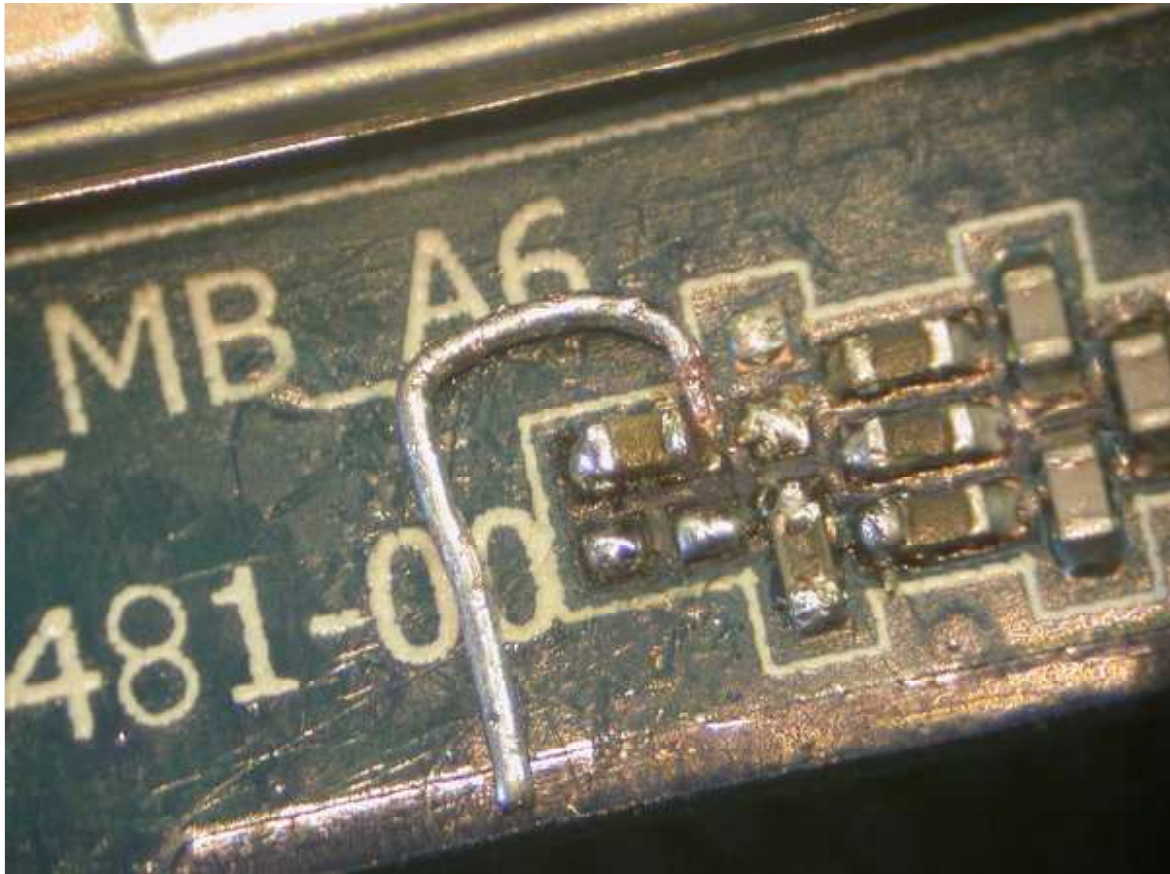
I cut a piece of wire and bent it to be as short as possible, bearing in mind it was the wrong thickness it could likely be made shorter.

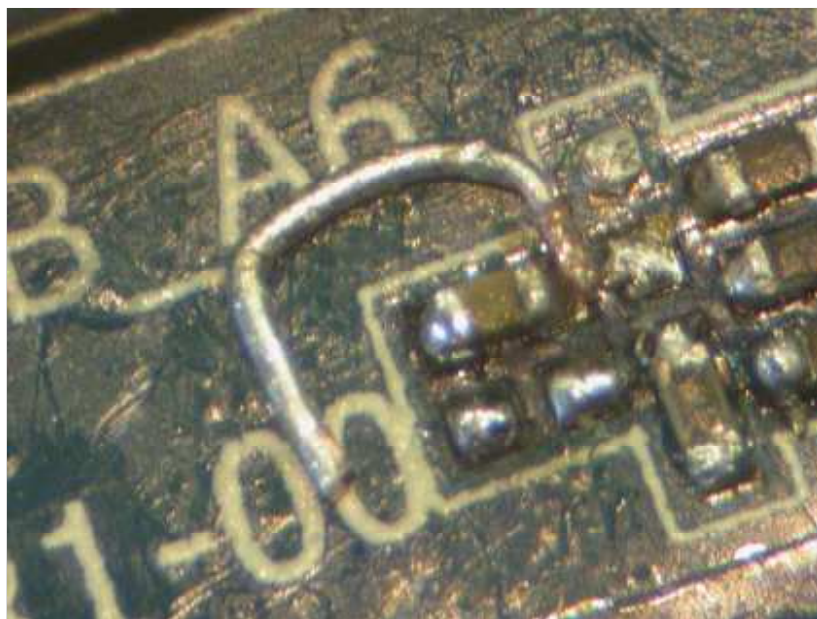
I then cut it to fit (I dropped the wire more than once so if the piece of wire changes in the next pictures that is why)

You will notice a missing capacitor C4303 that is because I bridged it with C4304 and ran the iron between the two to remove the bridge. This action accidentally removed C4303 and damaged it, I had to buy a replacement. A 0.4mm tip might seem like a small size but when dealing with form factor 0402 (1x0.5x0.25)mm it can be a little awkward (especially if you have a shaky hand).

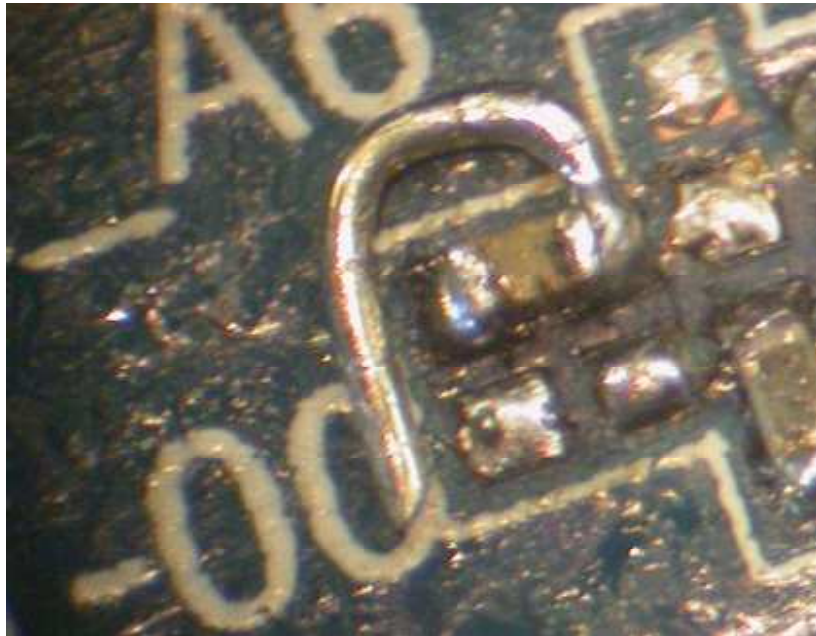
I decided to solder the wire to C4304 first and then place the 100 μ F cap on. This worked OK without melting the solder on C4304 when soldering on the 100 μ F cap.

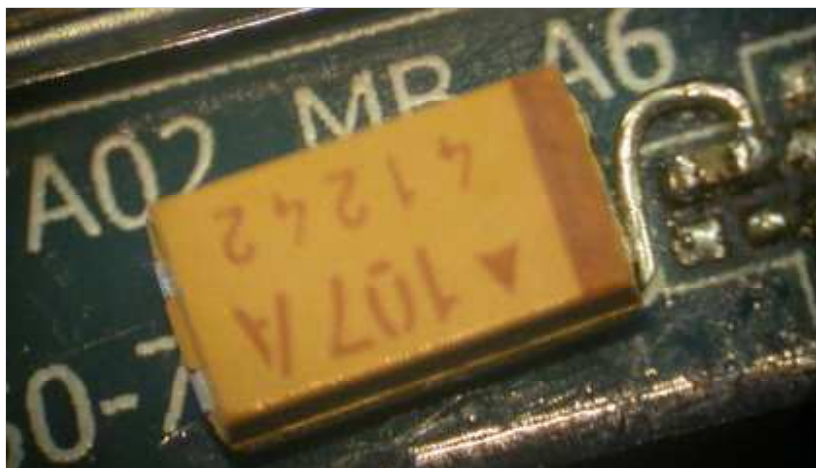
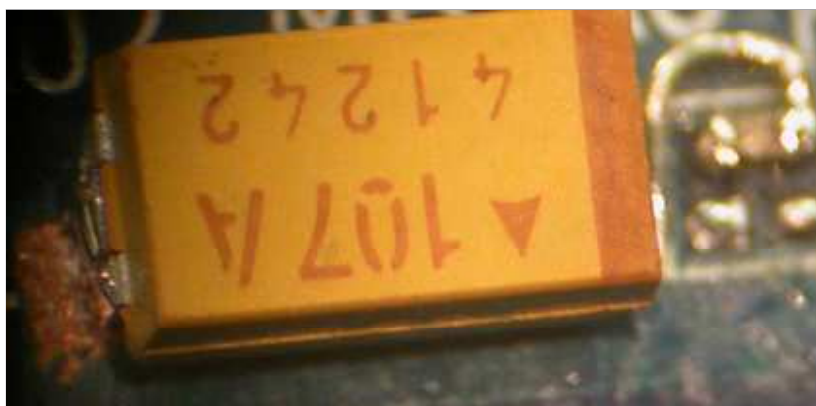
Next I placed the 100 μ F cap and marked where I should scratch off the paint on the motherboard. On these tant caps the +ve side (anode) has the line, as per the datasheet (see above link*)

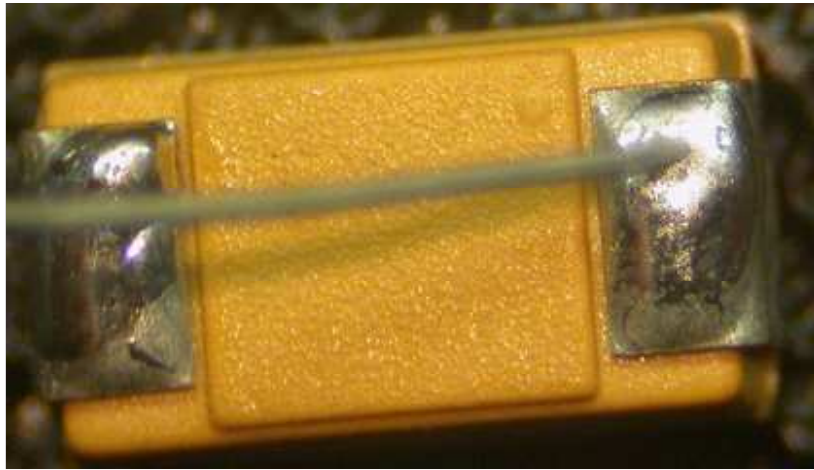
I tinned the pads on the cap, though I'm not sure if this is necessary, I'd recommend only a little.

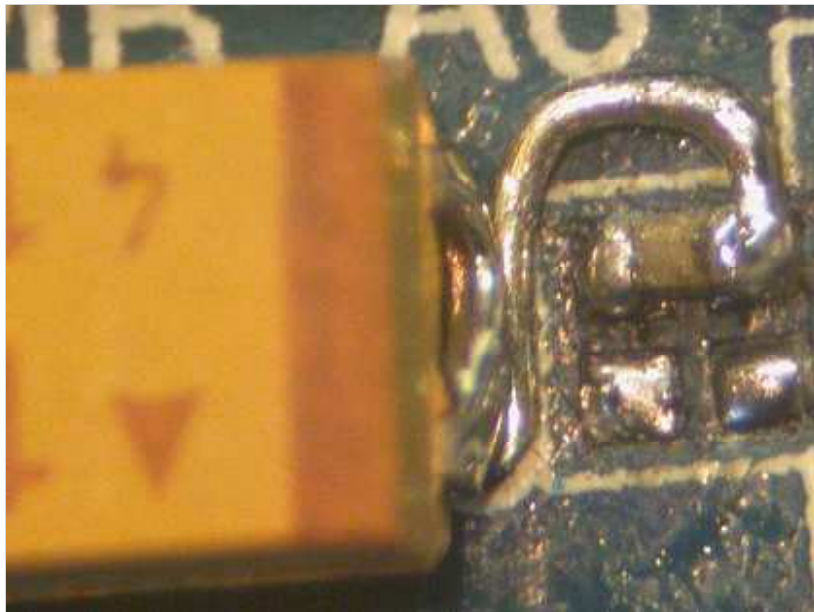
I soldered the anode first, this meant I wouldn't have to adjust the wire link.

The above joint was ok but from above it doesn't look like it has made contact, below I tidied it up. And replaced C4303. I desoldered the pads on the motherboard before replacing it

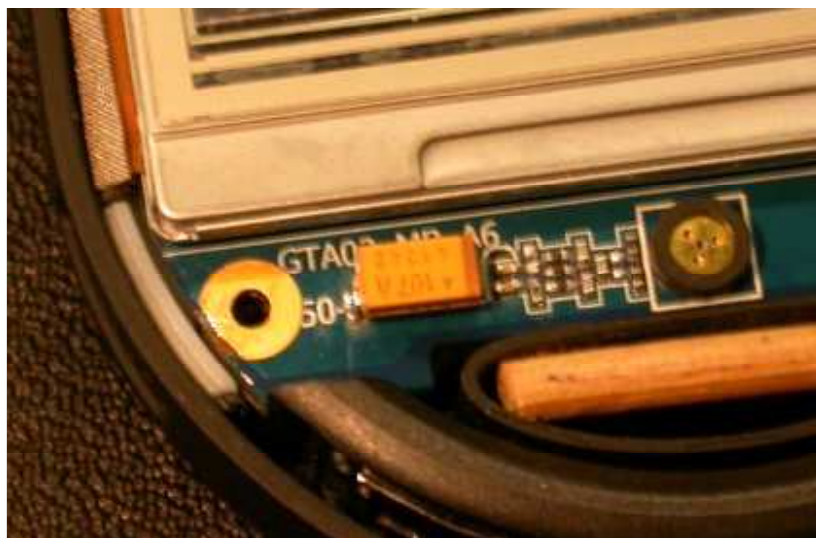
The case fits. So far I've had no complaints about the buzz, **but my voice is very low on calls.** :(Though I can't be sure it wasn't before, I know there are posts on this topic so I will read them next
